NASA CR-165351  
SRD-81-083

# THERMAL-BARRIER-COATED TURBINE BLADE STUDY

by P.A. Siemers and W.B. Hillig

**GENERAL ELECTRIC COMPANY**  
Corporate Research and Development  
Schenectady, New York 12301

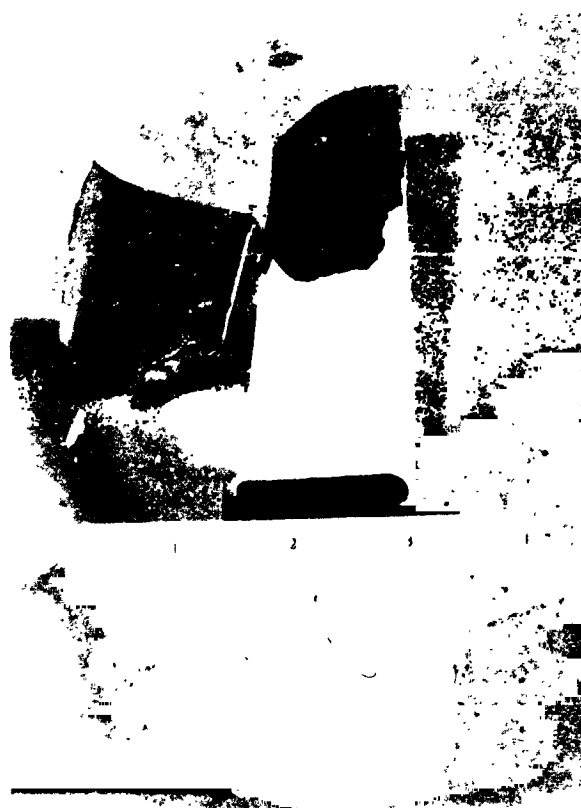
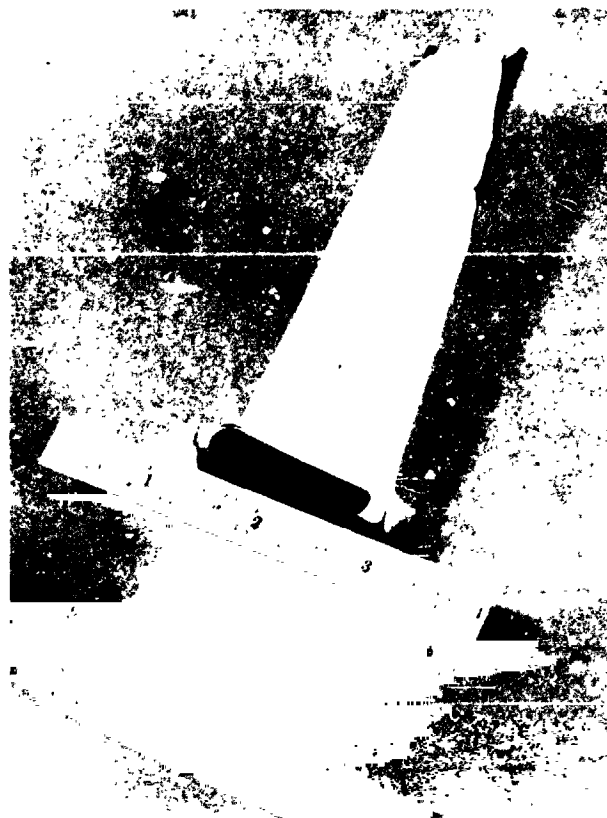
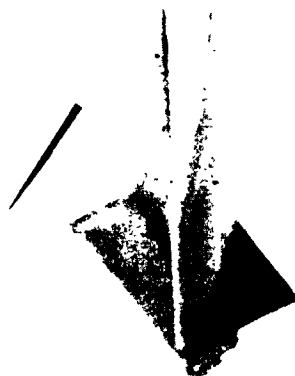
Figure 70

Photograph of air sprayed Ni-22Cr-10Al-1Y NiCrAlY and air sprayed 8 w/  $Y_2O_3$ - $ZrO_2$  on aluminided CF6-50 stage two blade after 160 cycles of furnace testing between 1100°C and 140°C. (a) Suction side of No. 1 blade; (b) pressure side of No. 1 blade; (c) trailing edge view of No. 2 blade.

A second pair of blades was tested under identical experimental conditions to confirm the first test. After 148 furnace cycles, the TBC on one blade developed cracks on the trailing edge. Testing was terminated after 160 cycles when both blades lost about 50% of their coating on the suction side. The failure occurred by peeling on one blade (Figure 70c) and by spallation on the other blade (Figure 70a). There was only a minimal loss of coating from the pressure side of one blade (Figure 70b) and no loss of coating from the platforms of either blade. In all cases spallation occurred at the aluminide/NiCrAlY interface, as evidenced by the dark, oxidized NiCrAlY adhering to the ceramic which had popped from the airfoil (Figure 70a). However, in some areas the more common mode of failure between the ceramic and bond coat layers occurred.

In order to determine the cause of spallation at the aluminide/NiCrAlY interface, the tip of one airfoil was sectioned and polished (right-hand blade of Figures 70a and 70b). Figure 71 shows micrographs of the blade sections where (a) NiCrAlY and ceramic had spalled from the aluminide surface, (b) NiCrAlY is just parting from the aluminide surface, (c) 8 w/o  $Y_2O_3$ - $ZrO_2$  spalled from the NiCrAlY, and (d) no spallation of any coating is occurring. In all cases there is some internal oxidation of the remaining NiCrAlY and an oxide layer (presumably  $Al_2O_3$ ) at the aluminide/NiCrAlY Rene'80 interface. This oxide may be responsible for the poor adhesion of the NiCrAlY, i.e., the  $Al_2O_3$  might weaken the bond at the NiAl/NiCrAlY interface.
